Service Tips Number # ST-012-01

- Enabling of the GVX9000 VFD on 15 through 25 Ton Packaged Rooftops

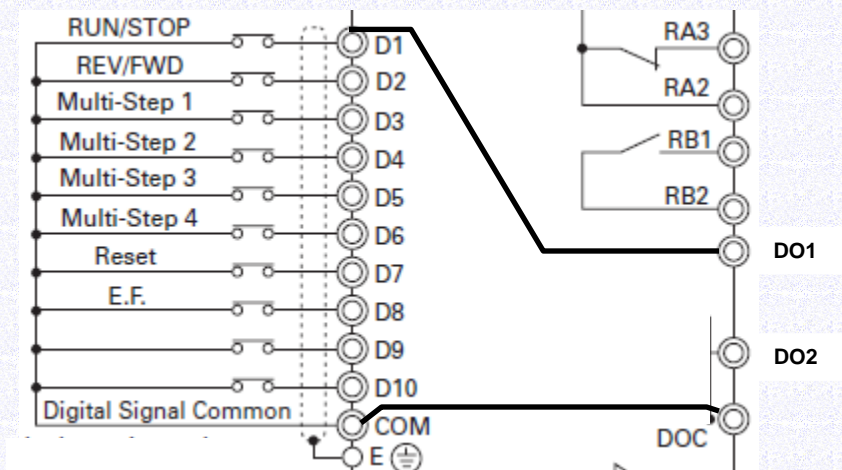
- There have been reports of the indoor blower motor not starting when commanded to energize on 15 through 25 ton package units that utilize the GVX9000 VFD. This usually occurs on a transition from unoccupied to occupied modes. It could also occur with a momentary interruption of power to the unit or any time the indoor blower is commanded ON during the unoccupied mode. The cause appears to be a timing issue between initializing, or power-up, of the vfd and the enable command, both of which are provided through a contactor that is energized by the FAN output on the Simplicity 1A control. The purpose of this letter is to provide an alternate method of enabling the vfd in order to eliminate the timing issue.

- Enabling of the GVX9000 during the time when the vfd is going through a brief initialization period can cause a condition where the vfd does not provide any output to the indoor blower motor even though the vfd display indicates an output. This can be remedied by using one of the GVX9000 relays for the enable command and eliminating the auxiliary contact on the blower contactor that is used for the enable command.

- Remove factory wires from COM and D1 and the GVX9000 terminal block and tie them back.
- Fabricate and install two (2) jumpers on the GVX9000 terminal block as follows:
 - COM to DOC
 - DO1 to D1
- Change the following GVX9000 parameters:
 - 40.05 to a value of 01 (READY)
 - 50.42 to a value of 01
 - 50.46 to a value of 0
 - 70.21 to a value of 2 secs
- The sequence after making the above changes will be:
 - Command the unit occupied or into any condition which requires the indoor blower operation
 - Indoor blower contactor is energized powering up the vfd
 - After the vfd initialization period is complete, the GVX9000 relay DOC to DO1 will close sending the enable command to D1, the RUN/STOP input
