VAST-14-002

Service Tip

Subject: Failure to light Issues on Furnaces using a Silica Nitride Hot Surface Igniter

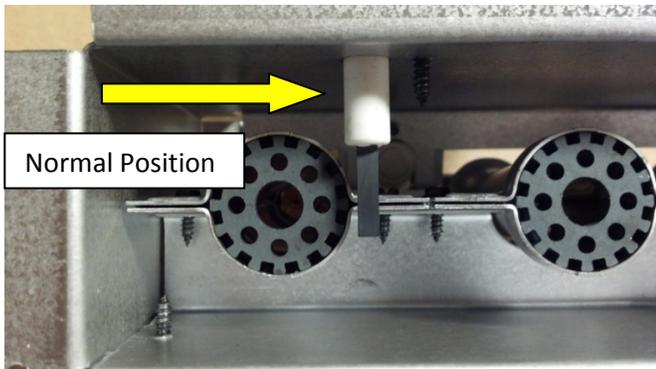
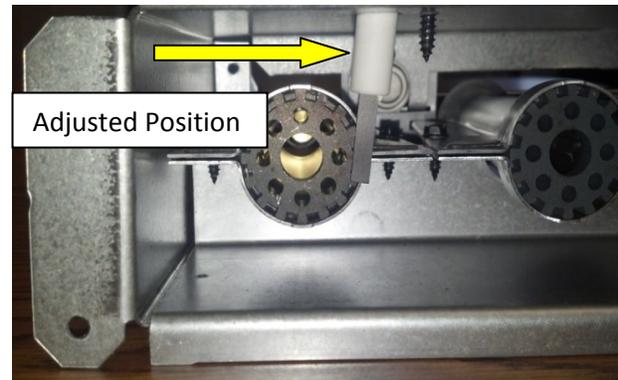
In April of 2013 York switched to using Silica Nitride igniters on most residential furnaces. Since that time we have had a small number of reports of furnaces not lighting on a call for heat. The tech can see the igniter glow and has already verified the manifold gas pressure is correctly set at 3.5"wc for natural gas. The ignition control board will eventually display a FC 7.

If you find a furnace with this issue, remove the screw holding the hot surface igniter to the burner box and carefully remove the igniter. With a pair of needle nose pliers, gently bend the bracket of the igniter so when you re-install it, the igniter will be at a slight angle. See pictures below. For reference purposes the amount of tilt is the equivalent of placing a nickel under the igniter bracket on the opposite side of the screw that holds the igniter in place.

Optionally, the existing igniter can be replaced with a Honeywell Glo Fly (Q3200U1004). This igniter is slightly longer than the original and reportedly provides the same relief as repositioning the original igniter.
