# Solutions for Fixing Common TEV Problems

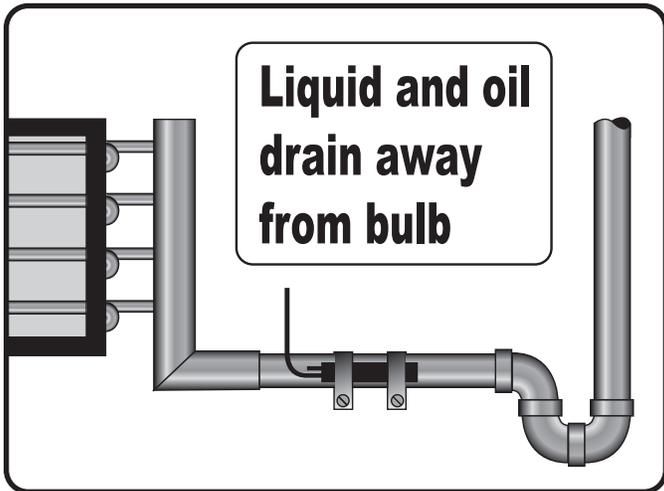
**The sensing bulb should be securely fastened to a clean, horizontal section of the suction line at the evaporator outlet.**

Verify the sensing bulb is correctly installed.

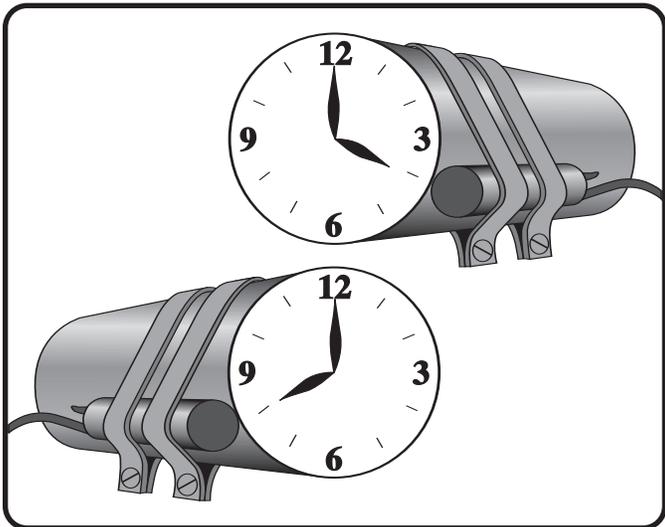
**On suction lines 7/8" and larger, the sensing bulb should be installed at 4 or 8 o'clock on the side of the horizontal line.**

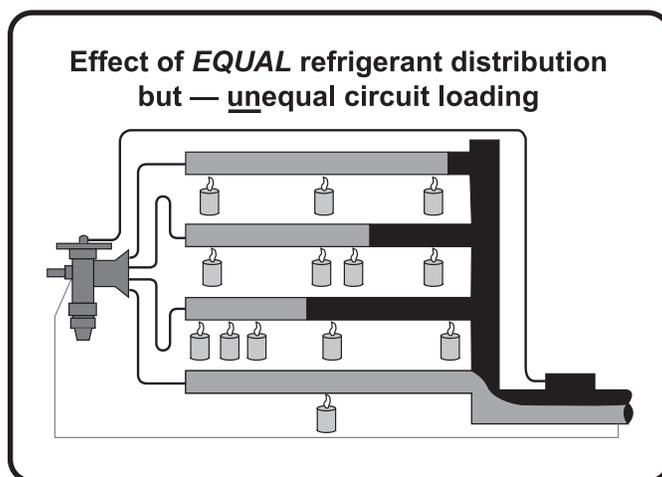
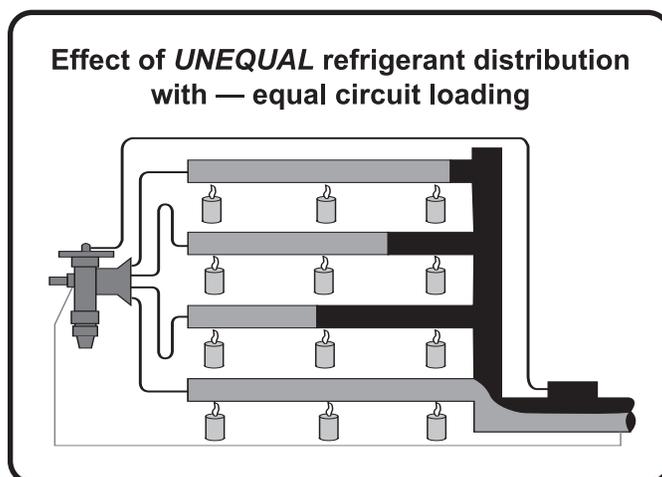
**These illustrations depict conditions that result in a loss of heat transfer due to either (top) unequal circuit loading or (bottom) unequal refrigerant distribution.**

**Loading:** Multi-circuit evaporators and parallel evaporators connected to a single refrigerant distributor must receive an equal percentage of the total load. When each circuit is not subjected to the same heat load, the lightly loaded circuits will allow liquid refrigerant or low temperature vapor to

enter the suction line and throttle the TEV. This will cause normally loaded circuits to be deprived of their share of the refrigerant. The net result is a loss of refrigerated evaporator surface and a potentially oversized TEV. Check the temperature of the suction outlets of each distributor circuit before the suction header. Unequal temperatures at these locations are the result of unequal loading.

Check with the equipment manufacturer for the correct distributor and nozzle assembly if poor distribution is diagnosed.
