Ducted Systems Technical Services Service Letter

Letter: **YS-004-2021**

Subject: **Residential control transformer defect – 208 Volt applications ONLY**

Summary: **This letter provides explanation and resolution for a control transformer defect that applies to the transformer 208 Volt power tap ONLY.**

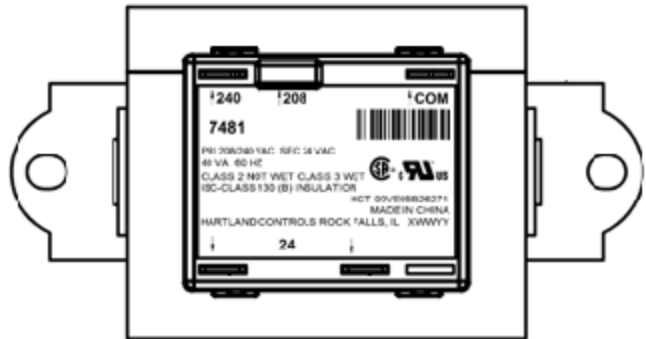
The above models utilize control voltage transformer 7481 which is service part S1-02518452700. Since 240 volt is the most common applied voltage, all equipment comes factory wired for 240 volt operation. Line voltage wiring is connected to the COM and 240 tap. There is a plastic cap on the 208 volt tap. Transformer 7481 is shown in the image to the right. The transformer label contains a date code.

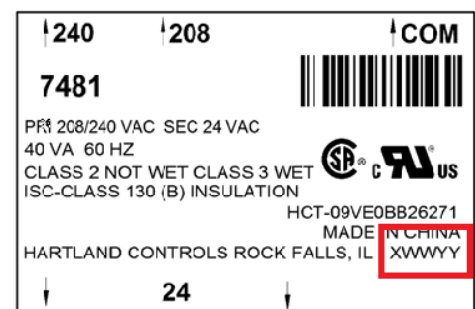
The date code can be found in the lower right hand corner of the transformer label. See the image on the right showing date code as XWWYY. There are 4 date codes involved with this defect. Transformers with date code N3220, N3320, N4120, and N4320 are 100% defective **IF** the transformer is to be wired for 208 volt operation. Transformer failure is instant if equipment is properly wired for 208 volt operation and line voltage power is applied. Typically no damage will occur to any other electrical device, however, this defect is an inconvenience for an equipment installer or equipment start-up service technician.

For equipment within the affected serial range that has been installed and operating, no further action relating to this matter is needed.

For equipment within the affected serial range that will be installed in a 240 volt application, no further action relating to this matter is needed.

Since the majority of equipment is installed in 240 volt applications the transformer defect will almost never be discovered as the 208 volt tap will go un-used almost always. What we do highly recommend though is a notice placed on each piece of affected equipment. The notice will advise of the defective transformer **IF** the equipment is to be applied with 208 volt power. An example of such notice can be found on the next page of this service letter. Even with the 208 volt tap transformer defect, the transformer can still be used with 208 volt power. This will allow the equipment to be started and used until a replacement transformer can be obtained and installed. For these situations this service letter should be used on a fix on fail basis only and only applies to installed equipment. This service letter will cover one S1-02518452700 transformer and 2 hours labor at the standard registered dealer labor rate.

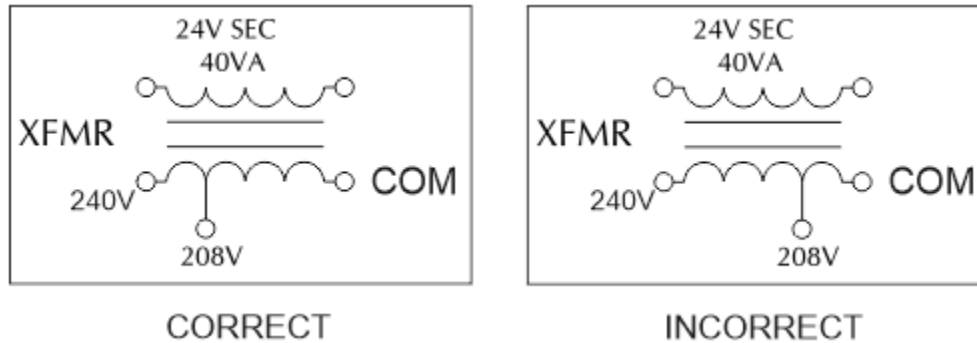
The images below provides a visual of the internal wiring of the control transformer. Notice the placement of the 240 and 208 voltage taps in relationship to the COM tap. The image on the left shows the 240 volt tap the furthest away from the COM tap and the 208 volt tap close to the 240 volt tap. The image on the right shows the 208 volt tap close to the COM tap. The image on the right shows the defect in which this service letter details. The connection of the 208 volt tap close to the COM tap results in low resistance across the taps and instant transformer failure will occur when wired for 208 volts and power is applied.

The earliest reports we have on file containing a defective transformer for this specific issue are from equipment built in September of 2020 which are serial numbers beginning with W2K0. However we must extend this serial number range back to August of 2020 as the earliest defective transformer date code is N3220 meaning the 32nd week of year 2020. **Serial number range for affected product is W2H0 through W2C1.** When this transformer defect was found, production of the affected models ceased and all part 7481 transformers were quarantined. No equipment built after 03/01/21 will have a transformer with this defect. No Source 1 transformers will have this defect.

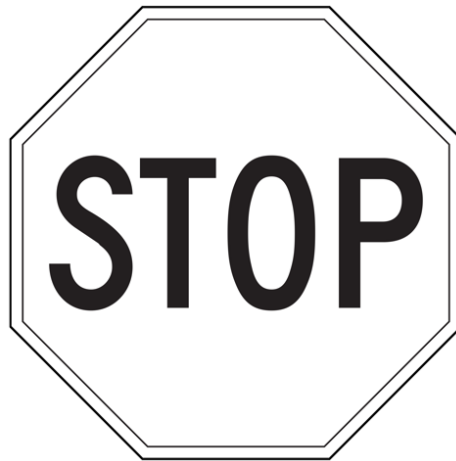
Prior to applying power to the equipment, inspect the label on the control transformer. The date code can be found in the lower right hand corner of the transformer label. See the image on the right. **If the date code reads N3220, N3320, N4120 or N4320, the 208 volt tap is located internally in the wrong location.**

If one of the above date codes is found, the transformer can still be used for 208 volt operation.

Contact your distributor to obtain a replacement S1-02518452700 transformer. There is also a DOA labor allowance available for this repair. Refer your distributor to service letter YS-004-2021 regarding this issue.
