# Solutions for Fixing Common TEV Problems

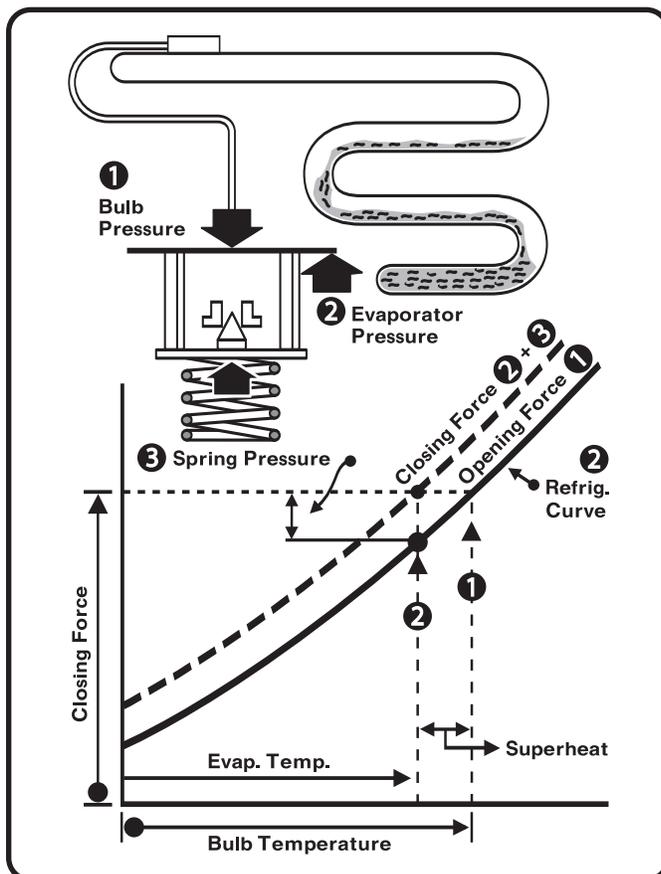
**#2 — Check the Sensing Bulb Location:** The sensing bulb should be securely fastened to a clean, straight section of the suction line. The bulb should not be influenced by ambient air temperature. The bulb should be attached to a horizontal suction line at the evaporator outlet. If the bulb cannot be located in this manner it may be located on a descending vertical line only. On suction lines 7/8" and larger, it should be installed at 4 or 8 o'clock on the

**The sensing bulb should be securely fastened to a clean, horizontal section of the suction line at the evaporator outlet.**

Verify the sensing bulb is correctly installed.
