VAST-17-02

Service Tip

Subject: YHE Outdoor Sensor Failures

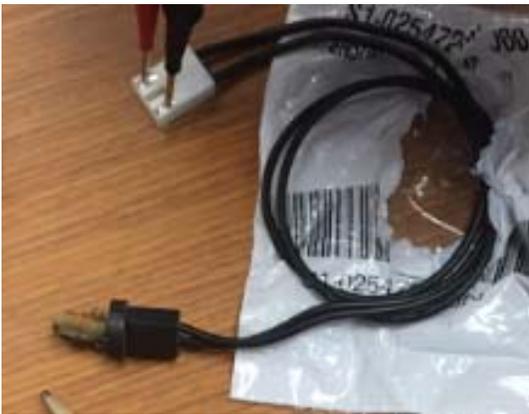
We have reports from the field of YHE outdoor sensor failures. We've tested some of the returned sensors finding most were either open, shorted or outside of the expected temperature to resistance range. The issue has been reported to the factory and they are working with their supplier so determine if this is isolated or part of a broader issue. The majority of returned sensors has come from our coastal customers but at this point we don't know for sure if that is coincidental or not but it part of the ongoing investigation.

The original sensor part number is S1-02547280000. The picture to the left shows the sensor along with some of the corrosion found on the tip of many of those we inspected. Until the factory completes their investigation they have approved the use of a replacement sensor (S1-02532701016). See the picture on the right.

Take note that the plug on the end of the original sensor *must be reused* as the replacement sensor does not have the termination plug. The technician cuts the plug off the original sensor then cuts the stay-con connectors off the new sensor, using wire nuts with electrical tape to splice the wires. Applying dielectric grease to the spliced connection points is a good practice to protect it from corrosion over time. The end of the new sensor can be allowed to hang from the bottom of the box. We can provide the sensor and 1 hour of labor to a contractor who experiences the failure but each one must be submitted to York's field service group for an SI. We are asking that all failed sensors be returned to your local VA Air branch as we are testing and returning them to the factory to assist with this investigation.
